Creciente Condominium Association, Inc.

Structural Integrity Reserve Study

For Period Beginning July 1st, 2025.

7146, 7148, & 7150 Estero Blvd., Fort Myers Beach, FL, 33931

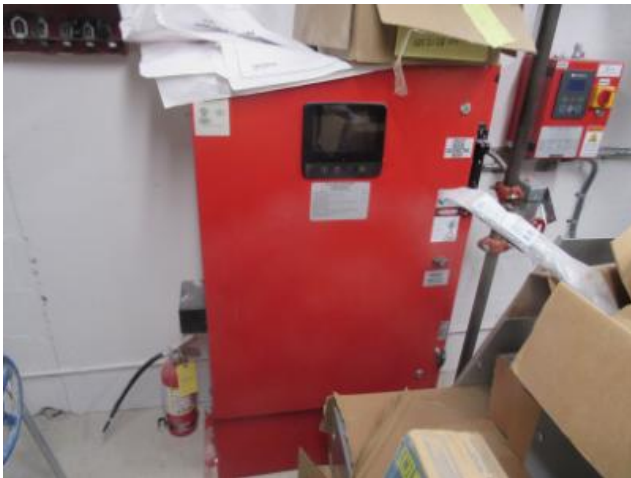
The fire pump and controls are located in the pump room in the garage. We understand the subject building has a 1.5hp jockey pump, which was installed circa 2024. These types of systems generally have a useful life of 40 years under routine maintenance. We have included a reserve for replacement/repairs to the system as needed.

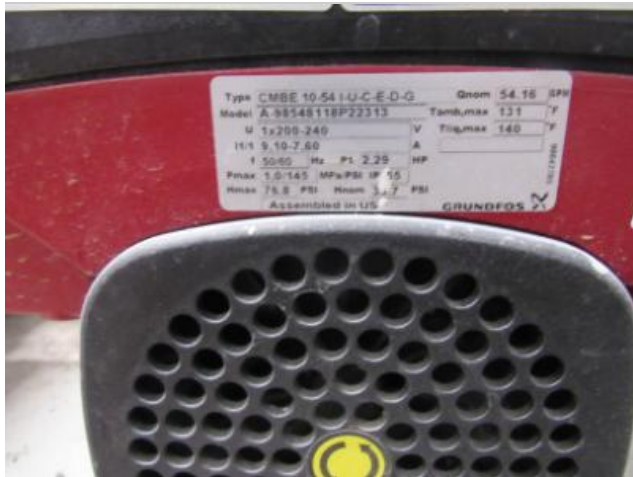
The domestic water pump and control system for the building are located in the pump room in the garage. This reserve budget includes the replacement of the control panel and repairs or replacement to the motors/pumps as needed. Our experience indicates a useful life of 25 years. Installation circa 2024.

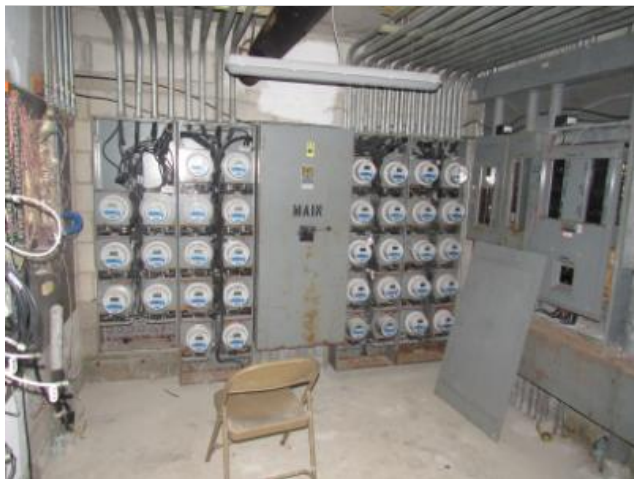
The main disconnects and breakers are located on within the Meter Room in the garage. Localized breaker panels and branch circuits are typically replaced during common area or individual unit renovations as required to accommodate the renovation. Therefore, a reserve has been included for partial periodic replacement/upgrades of major electrical system components such as service panels and breakers.

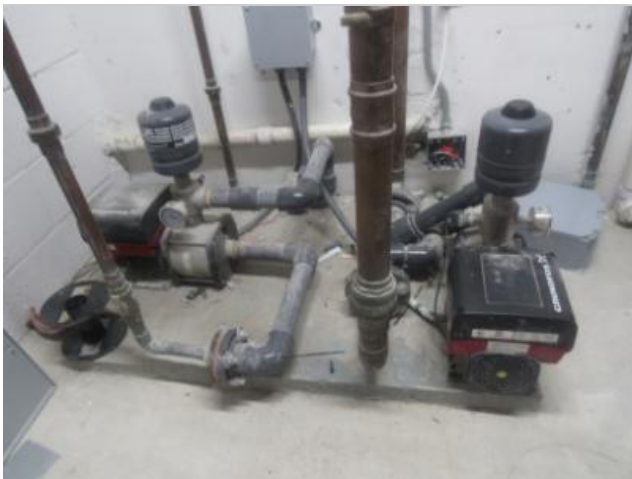
39 - Building 7150 - Domestic Water Pumps & Controls

The domestic water pump and control system for the building are located in the pump room on the first floor. This reserve budget includes the replacement of the control panel and repairs or replacement to the motors/pumps as needed. Our experience indicates a useful life of 25 years. Installation circa 2024

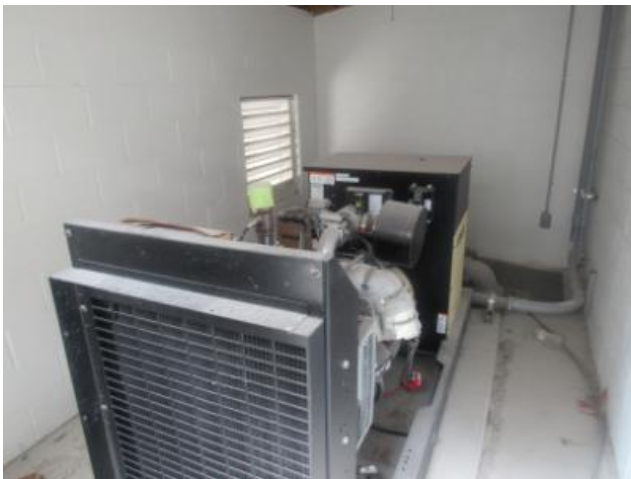
The building's emergency generator is located in the generator room at the South side of the building. It is a 2000kw propane powered generator with a buried tank. Typically, propane generators and related equipment have a useful life of approximately 35 to 40 years. A reserve has been included for replacement of the generator and related equipment. Installation circa 2024.

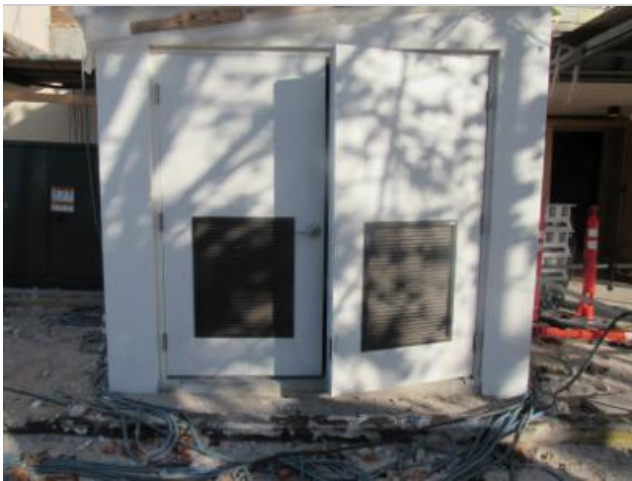
49 - Building 7150 - Exterior Metal Doors

Exterior metal doors found on first floor and roof access (hatch). Typical useful life of 35 years has been reduced to 20 years due to environmental conditions. Installed circa 2024.
