SOCOTEC

CRECIENTE CONDOMINIUM ASSOCIATION, INC.

Subject: Report of Engineering Consulting Services
MILESTONE INSPECTION – PHASE I
7146 Estero Boulevard (North Building)
Fort Myers Beach, Lee County, FL 33931
SOCOTEC Project Number VS240184

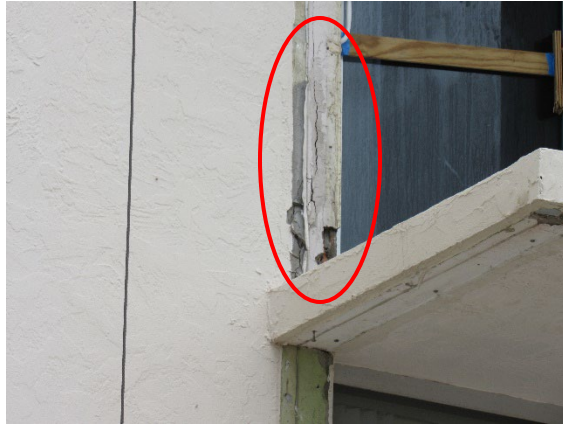
<p>Overall view of Building East and South Elevations</p>	<p>Concrete Spalling at a Shear wall South Elevation</p>

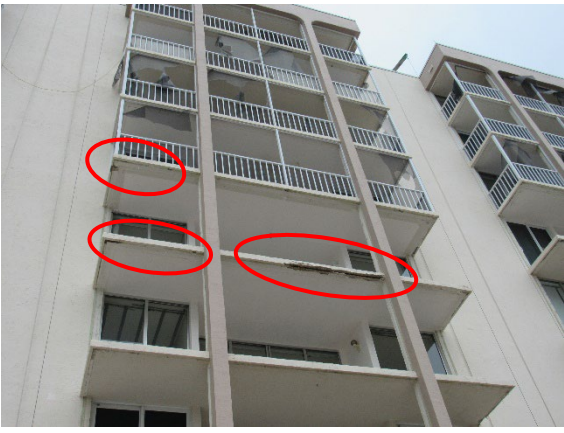
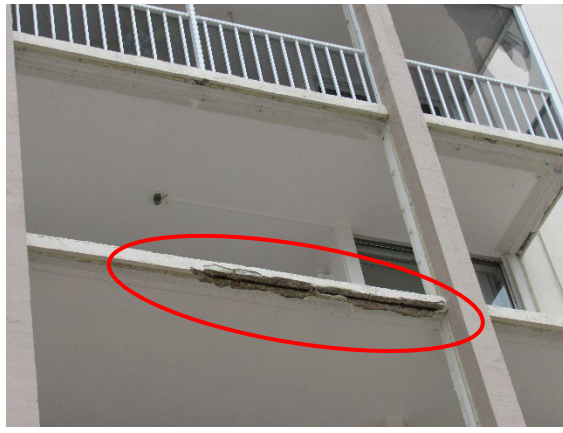
<p>Concrete Spalling at Deck Edge South Elevation</p>	<p>Concrete Spalling at Deck Edge South Elevation</p>

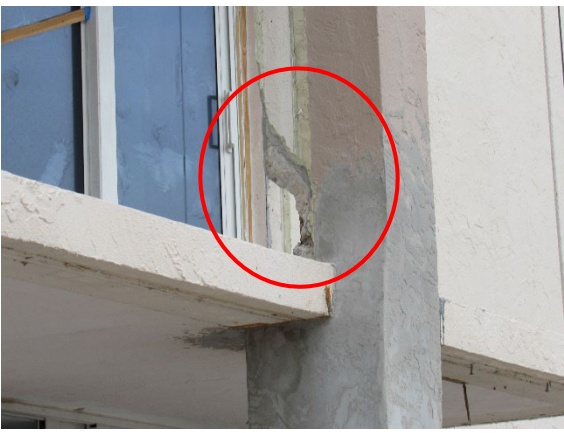
<p>Concrete Spalling at a Column South Elevation</p>	<p>Damaged Railing/Screen Enclosure South Elevation</p>
