SOCOTEC

CRECIENTE CONDOMINIUM ASSOCIATION, INC.

Subject: Report of Engineering Consulting Services
MILESTONE INSPECTION – PHASE I
7148 Estero Boulevard (East Building)
Fort Myers Beach, Lee County, FL 33931
SOCOTEC Project Number VS240184

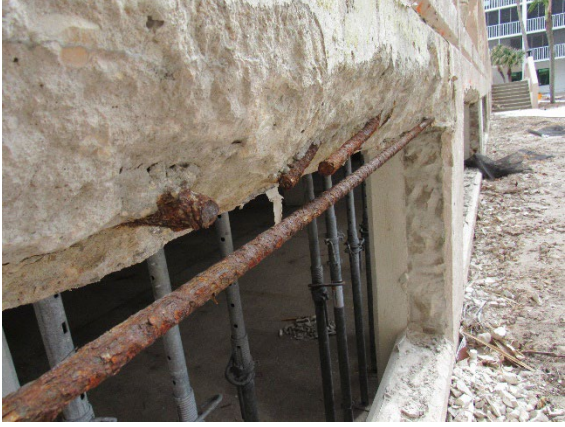
Concrete Spalling at Garage West Elevation	Concrete Spalling at Garage West Elevation

Concrete Spalling at Garage West Elevation	Concrete Spalling at Deck Below Building Within Garage
