CRECIENTE CONDOMINIUM ASSOCIATION, INC.

Subject: Report of Engineering Consulting Services
MILESTONE INSPECTION – PHASE I
7150 Estero Boulevard (South Building)
Fort Myers Beach, Lee County, FL 33931
SOCOTEC Project Number VS240184

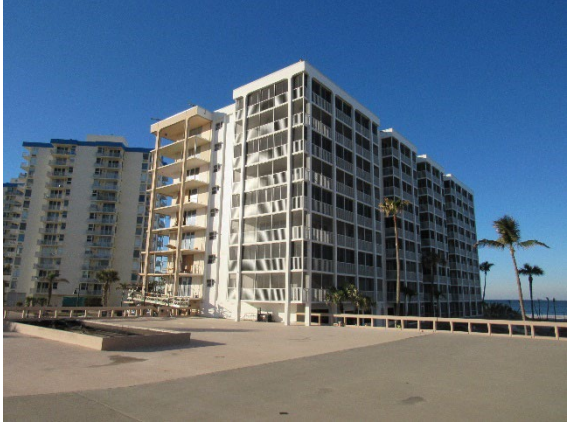
<p>Overall view of Building East and North Elevations</p>	<p>Concrete Restoration In-Progress South Elevation</p>

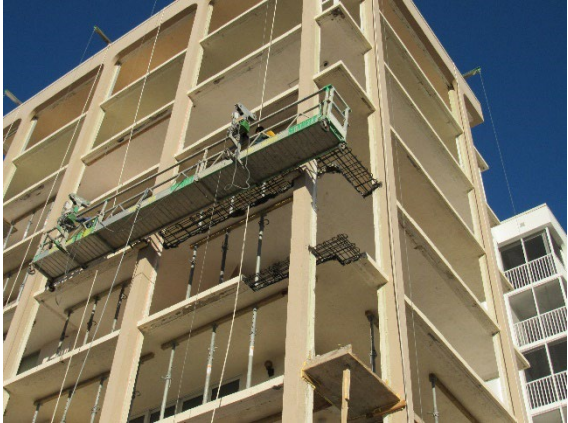
<p>Concrete Restoration In-Progress South Elevation</p>	<p>Concrete Restoration In-Progress South Elevation</p>

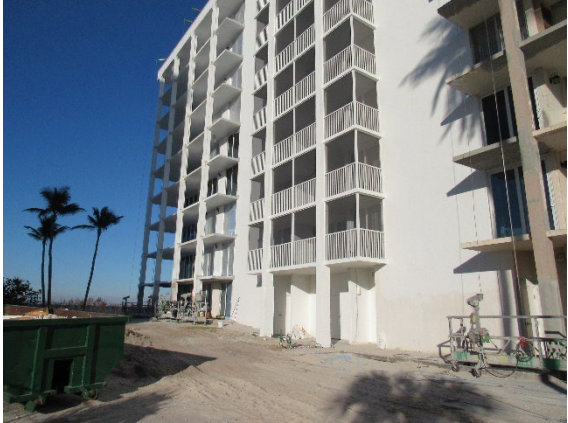
<p>Railing/Screen Enclosure Installation In-Progress</p>	<p>Balcony Waterproofing and Building Painting In-Progress</p>
